KCC WHITE PAPER

2022 North Atlantic Hurricane Season in Review Including Post-Event Damage Surveys for Hurricane Ian

April 2023

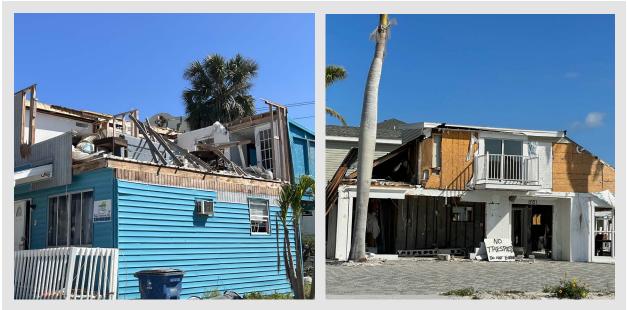
Wind damaged the roof structures of single-family homes in Fort Myers Beach, which led to progressive damage to the wall structures and total losses in many cases.

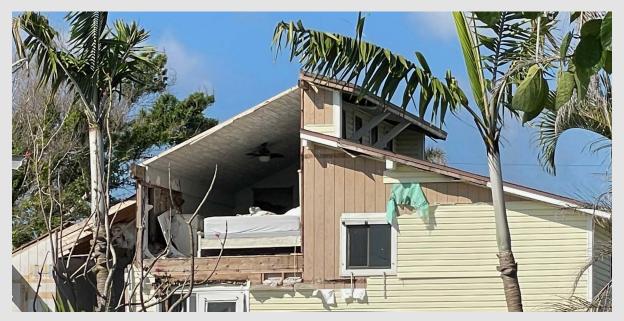
Extreme structural damage to the wood frame wall of this Pine Island home led to severe interior damage. Damaged windows and breaches on the gable caused higher pressure on the roof and wall. The wall structure in this building collapsed even before the roof structure failed.

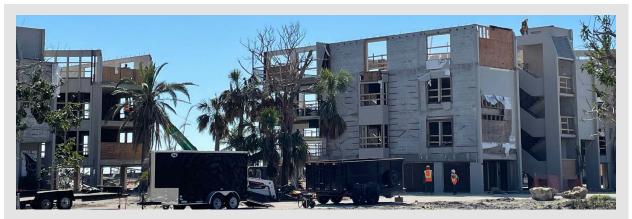
The flat wooden roofs on these multifamily residences were compromised, which increased the pressure on openings and walls and caused them to fail. Once the building envelope is compromised, wind and water can fully damage the interior, resulting in a total loss.

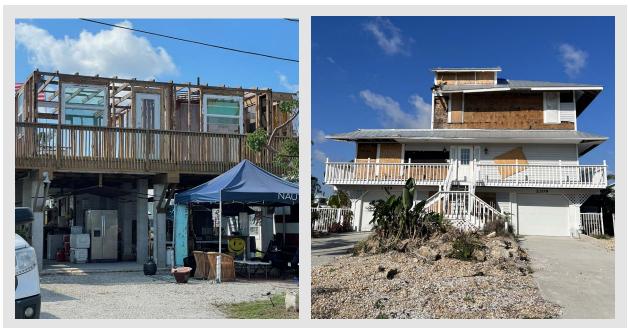
The detachment of roof components is the most common reason for a loss of structural integrity due to high winds. These Pine Island homes were built before the first wind engineering based design requirements, so the wind speeds from Hurricane Ian exceeded the design wind speeds.

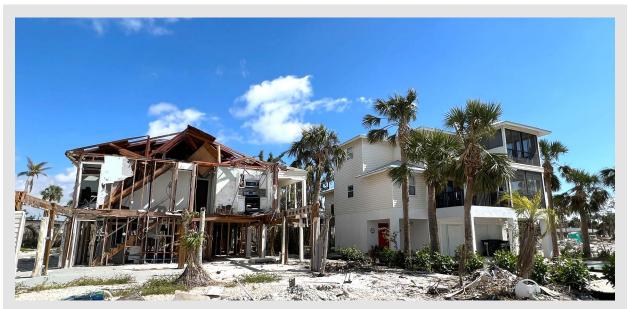
The home on the left was constructed of wood frame with a shingle roof in 1972, while the home on the right was constructed of masonry with a metal roof in 1997. The wood frame home was completely destroyed, while the masonry home sustained only minor screen damage and water leakage.

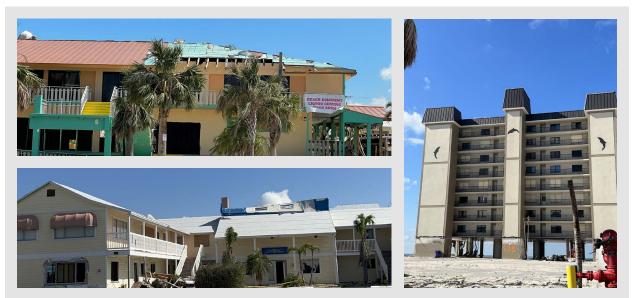
Masonry commercial buildings in Fort Myers Beach (left) sustained extensive roof covering and decking damage, which caused progressive interior damage. Reinforced concrete buildings (right) were minimally damaged in most cases.

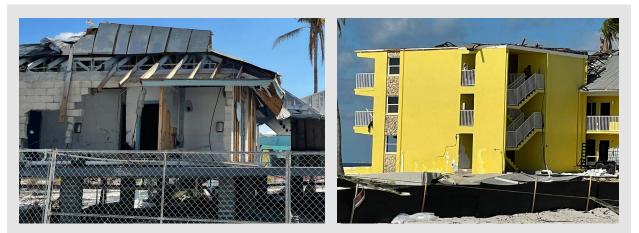
As observed in previous events, metal roofs generally perform better than other roof covering types, but they can fail in Category 4 winds. Defective engineering, malfunctioning components (such as rusted panels or fasteners), or faulty installation (such as insufficient fasteners or incorrect clip spacing) are often the main reasons for metal roof failure. The KCC team observed isolated cases of metal roof damage, particularly in commercial and multifamily residential buildings.

Wind peeled the metal roof of a public building from its rafters (left) and sheared the metal roof completely off a multifamily building (right).

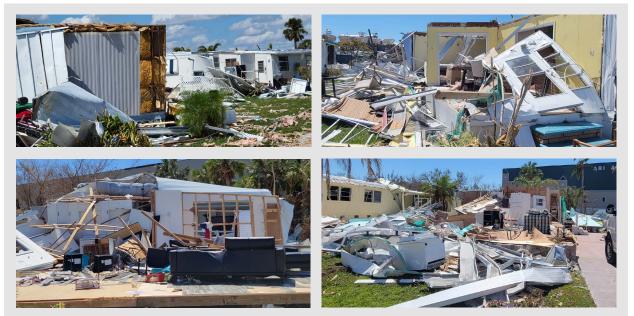
Many manufactured homes in Placida were completely destroyed with detached roofs and collapsed walls.

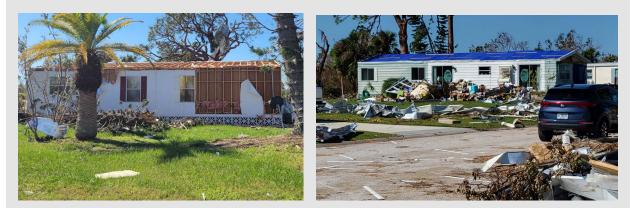
Manufactured homes in Englewood sustained extensive interior damage due to water infiltration from exposed roofs and walls when the roof cover and wall siding were damaged by high winds.

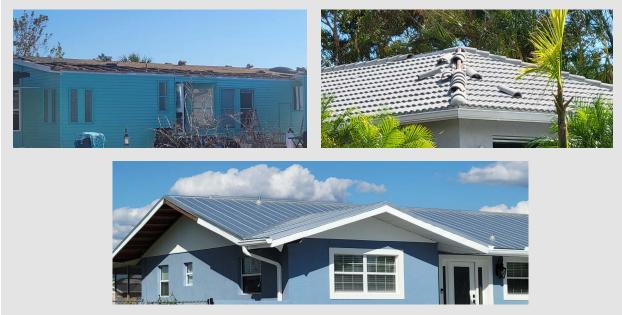
Shingle and tile roofs suffered the most extensive damage compared to metal roofs, which tend to perform better for a several reasons. First, metal roofs are made with overlapping panels that interlock on all sides. These interlocking panels increase the roof's wind resistance by preventing high winds from getting under the roof covering and creating uplift. Second, metal panels are tougher than other materials and therefore are less impacted by wind-blown debris—the roof may dent but tends not to leak or fail. Third, metal roofs are secured in place more robustly than tiles or shingles. Over time, the adhesives that hold tiles or shingles to a roof may break down, while metal roofs generally remain firmly locked in place.

Shingle (upper left) and tile (upper right) roofs were often damaged by Category 3 wind speeds, whereas metal roofs (bottom) performed better.

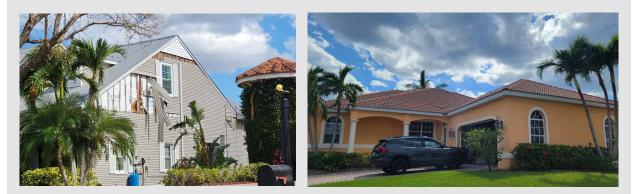
Many instances of siding damage were observed. Stucco siding generally outperformed vinyl siding, which was frequently damaged by suction and debris impact.

There were many instances of damaged vinyl siding (left), while heavier siding options, like stucco (right), exhibited better performance in Category 3 winds.

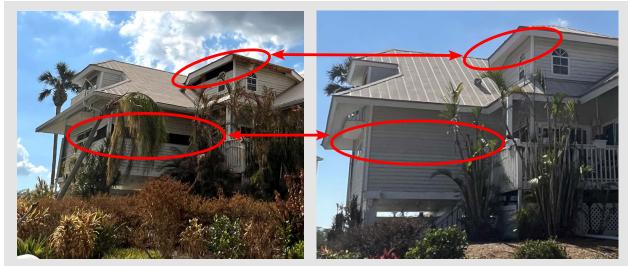
A home in Fort Myers patched siding and soffit between the first KCC damage survey in October 2022 (left) and the second in March 2023 (right).

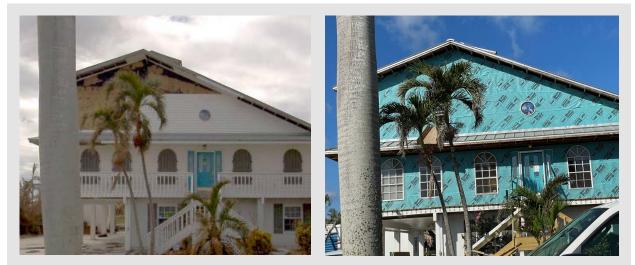
A home in St. James City on Pine Island pictured in March 2023 (right) undergoes siding replacement after losing only part of its siding in October 2022 (left).

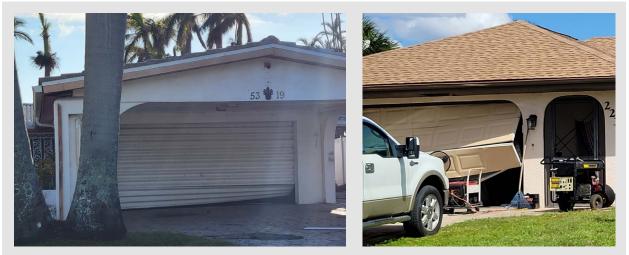
Garage doors are another common mode of failure in Category 3 wind speeds, as high winds can cause garage doors to bulge and warp. At these wind speeds, garage doors are also susceptible to misalignment and jamming that may not be immediately visible. Garage doors are typically the largest opening in a home and therefore the most vulnerable to wind pressures. If a garage door is compromised, the internal pressure on the roof and walls increases and creates higher wind loads on the overall structure, which then increases the likelihood that the roof or walls will fail.

Garage doors in Cape Coral (left) and Port Charlotte (right) warped and buckled.

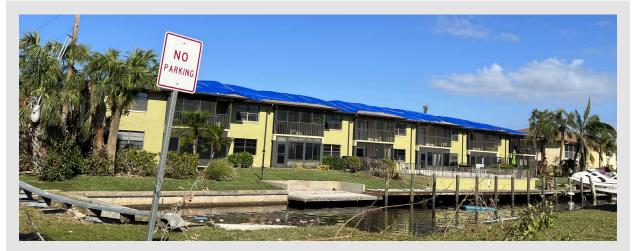
The tile roof on a multifamily residential structure in Cape Coral sustained severe damage.

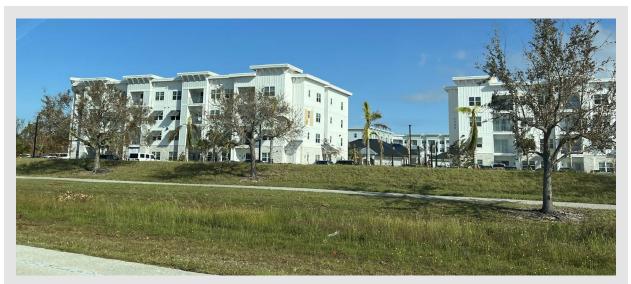
A multifamily residential structure in Cape Coral appears undamaged. The roof of this building is a built-up wood deck system, which is much more wind-resistant than tile.

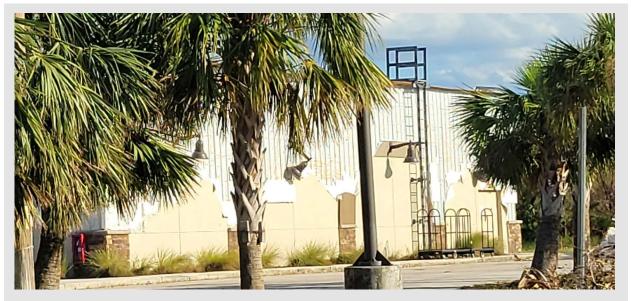
Exterior Insulation Finishing Systems (EIFS) are a popular siding material for commercial and multifamily residential buildings because it is regarded as affordable, attractive, and easy to install. This type of wall siding is especially vulnerable because it is light-weight and detaches easily from the underlying structure. Wind can exploit small cracks and cause significant siding damage, which can then lead to extensive interior damage due to water infiltration.

EIFS panels peeled from a building in Cape Coral, demonstrating why it should not be used in hurricaneprone areas.

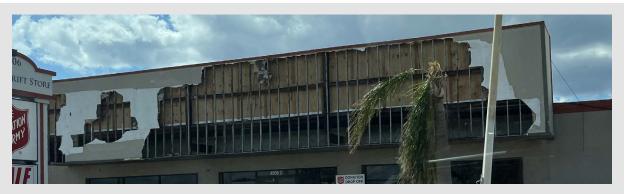
Wind-damaged signboard on a retail store in Cape Coral

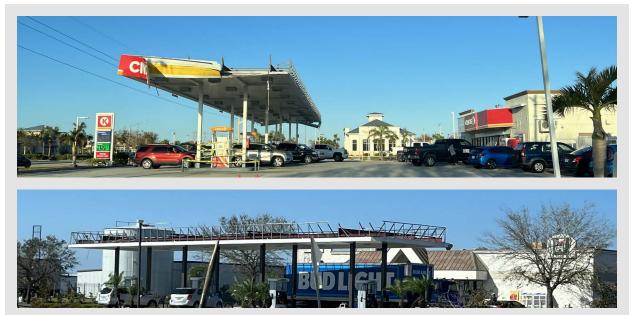
Category 3 winds frequently damage the roof covering and siding of gas stations. Gas station pavilions are particularly vulnerable to wind uplift forces due to their light weight and broad surface area.

Gas station pavilions sustained heavy damage from wind uplift due to their light weight and large surface area.

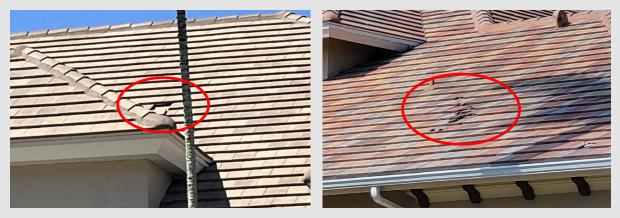
Minor roof damage in Naples (left) and Marco Island (right)

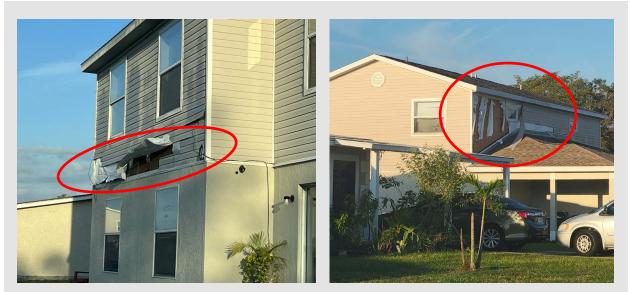
Moderate wall siding damage in Sebring

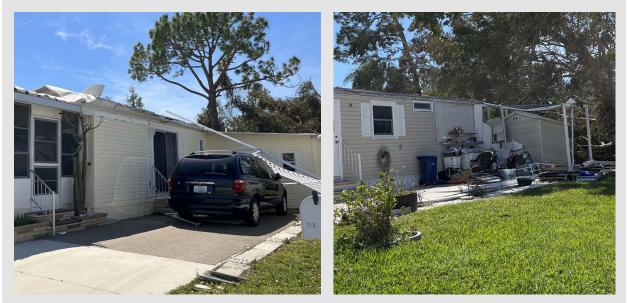
The attached structures of these manufactured homes were lifted up from pressure below the structure. Because these structures are connected to the roof, parts of the roof are also progressively damaged, first because of wind-induced vibration and then because of full lift off of the attached structure.

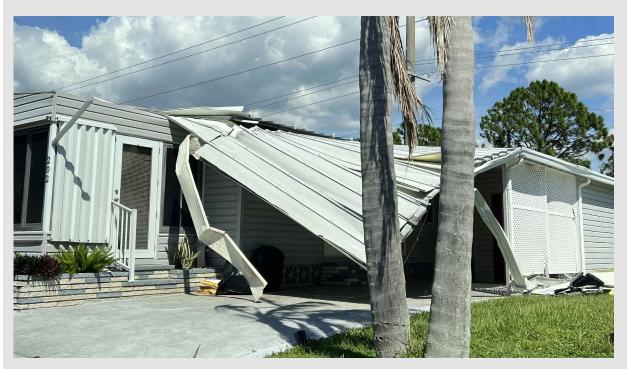
This manufactured home lost part of its roof after an attached structure was damaged.

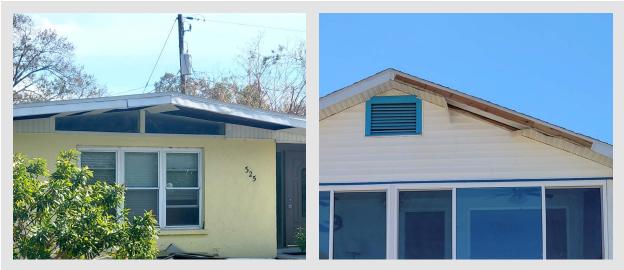
Examples of soffit damage in Venice (left) and Bradenton (right)

A common pattern of soffit failure occurs when the wind removes the fascia and exposes the soffit edge, which allows the wind to pry it loose and strip the panels off the building.

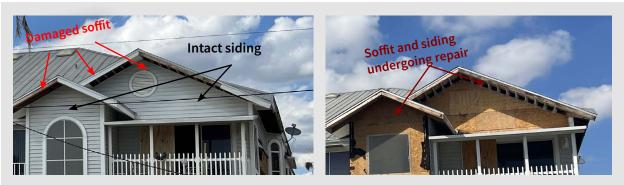
Example of siding repair following soffit damage. The siding of this home was not damaged in October 2022 (left) but was undergoing replacement in March 2023 (right), likely due to water infiltration after the soffits were damaged.

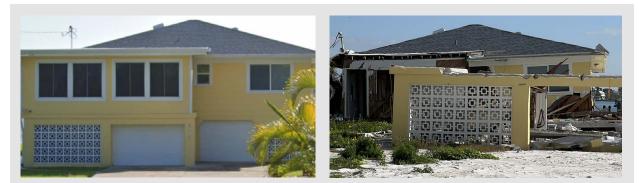
This home in Fort Myers Beach (shown before Ian on the left and after on the right) was shifted off its foundation due to storm surge and sustained extensive structural damage leading to a total loss. Not only did the foundation connection fail, but the foundation itself partially collapsed because it was a relatively old building (built in 1952).

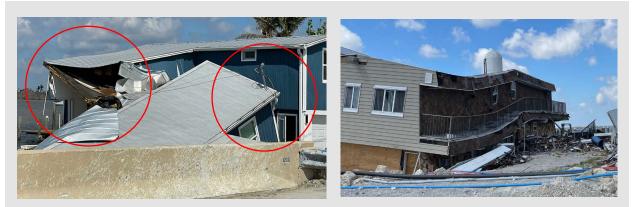
Storm surge can cause a failure of the foundation connection and foundation of coastal buildings, resulting in total losses. These homes were built on solid wall foundations, which failed due to storm surge.

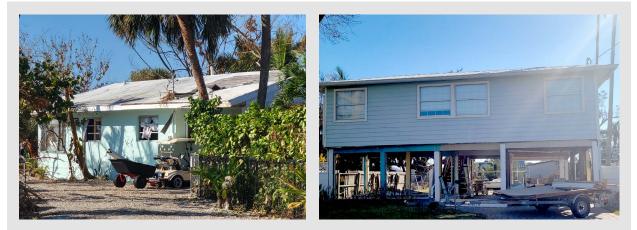
These Bonita Springs homes were impacted by similar levels of surge but while the home with a first floor at ground elevation (left) was a total loss, the main living space of the elevated home (right) was only minimally damaged.

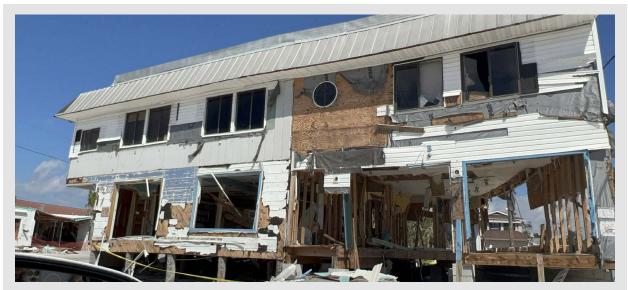
This building on Fort Myers Beach has a first floor that is about four feet above ground level, but the storm surge in this location was twelve feet, which led to storm surge damage on the first-floor structure and extensive interior losses. In addition to the surge damage, the second-floor wall siding and openings were severely damaged by high winds.

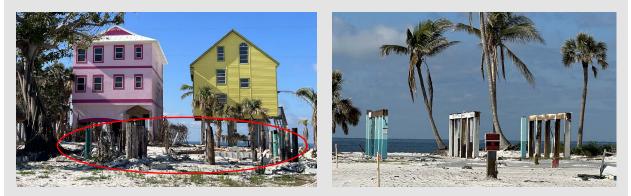
The buildings on the left have higher first-floor heights and stronger foundation connections, which left them undamaged by the storm surge while nearby homes were swept away (as shown by the piles left behind in the foreground, circled in red). The photo on the right shows piles left behind by a building with a lower first-floor height and poor foundation connections, which made it vulnerable to storm surge and led to the entire building being swept away.

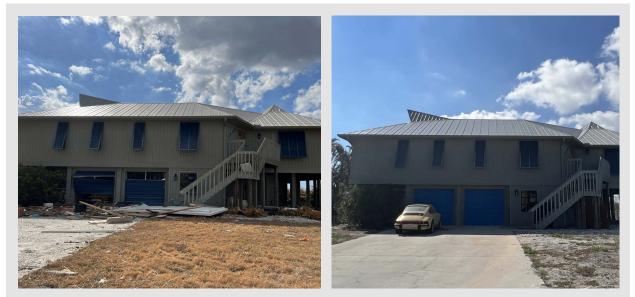
Between the two damage surveys, a home in Fort Myers pictured in October 2022 (left) and March 2023 (right) underwent garage door repairs and was cleared of debris.

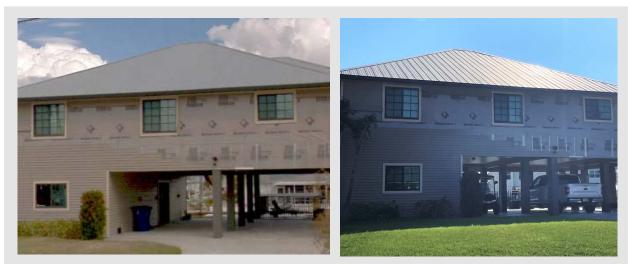
A single-family home in St. James City on Pine Island pictured in October 2022 (left) and March 2023 (right) with no exterior repair progress.
