SAFETY LESSONS FROM THE RI TRAGEDY

Following The Station Nightclub Fire, Beacon Mutual Insurance Co. Inspectors Visited 142 Similar Hospitality Establishments and Here's What They Found

by Michael Ehrmantraut, OHST
Beacon Mutual Insurance Co.

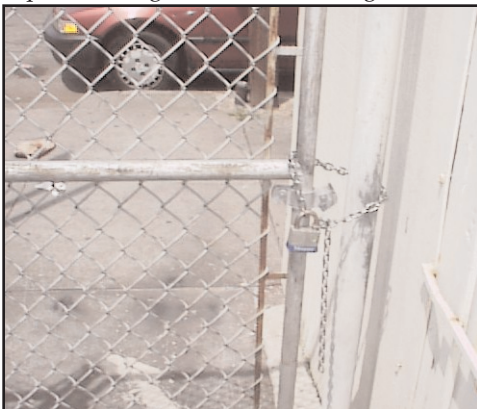
Blocked exit paths and locked exit discharges

Some places were found with blocked exit paths and locked exit discharges. (Photos were taken in various Rhode Island establishments.)

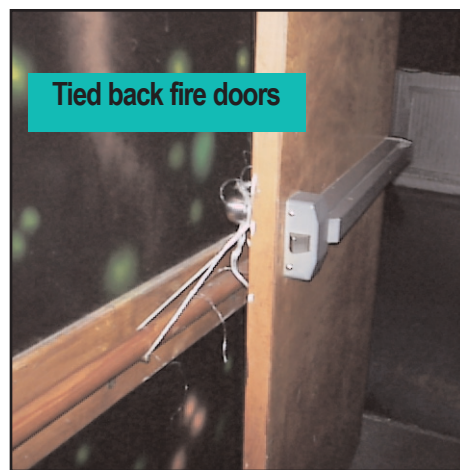
Tied back fire doors

Some venues had tied back their fire doors, which were located in stairwells. Having these fire doors restrained is extremely dangerous, because, in the event of a fire, smoke and heat would travel up the staircase and block the exit completely.

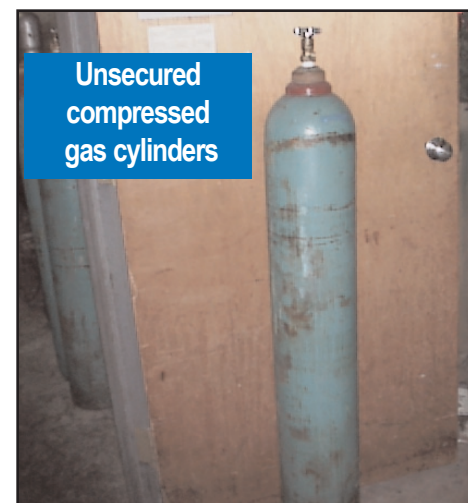
Unsecured compressed gas cylinders

In addition to eliminating safety hazards to patrons, the Beacon staff also worked to mitigate potential hazards to employees of the establishments. For employees, the most common hazards were unsecured compressed gas cylinders. Almost every facility has these bottles, similar to the cylinder shown in the photo, for soda fountains. These vessels should always be secured to a wall with a chain. If a vessel was to fall over, and the valve knocked off, the vessel could become a missile, flying through any type of wall until expended. An additional hazard arises if the bottle falls on someone's foot and impairs successful evacuation.
