KCC WHITE PAPER

2022 North Atlantic Hurricane Season in Review Including Post-Event Damage Surveys for Hurricane Ian

April 2023

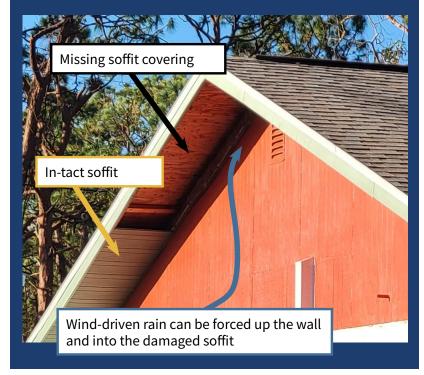
Soffit damage also occurs when wind directed upward by the sidewall pushes up soffit panels, forcing them to come out of their channel support. Corners are especially vulnerable to this type of damage and two-story buildings are more susceptible than onestory buildings.

Soffit damage can also occur from downward pressure (also known as suction pressure) when the pressure difference between the outside and inside of the panel is so great that the soffit is pulled downward out of the channel. In most cases of soffit damage, only the soffit itself needs replacing, but water infiltration can result from even minor damage. A soffit is the exposed siding beneath a roof's overhang. When a soffit is damaged, it can expose the interior of the building to wind-driven rain and lead to significant water damage. Under damaged soffits, the attic, interior walls, and siding are all vulnerable to water damage.

Soffit damage can necessitate complete replacement of a building's siding because wind-driven rain gets under the siding and into the walls. Rainwater can also be driven over the exterior wall into wall breaches and attic spaces. Water infiltration can then lead to significant interior damage, increasing the ultimate loss.
